F-1-200 George W. Myers Farmstead Adamstown Frederick County

# 7. Description Survey No. F-1-200

# Maryland Historical Trust State Historic Sites Inventory Form

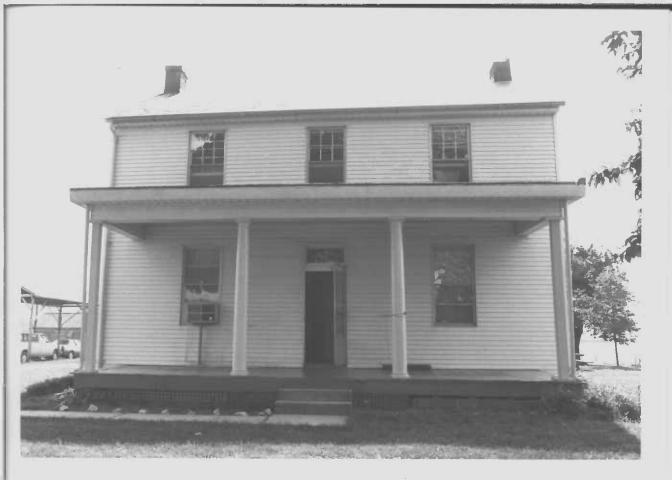
The main dwelling has a three-bay west elevation with a one-story porch. A two-story rear wing extending from the northeast corner of the main section has beer considerably altered, almost obscuring the original two-story porch on the sout elevation with enclosed sections and modern sash. The exterior is covered with vinyl siding and the gable roof is slate with interior end chimneys. The center entrance on the west elevation has a rectangular fanlight, a feature more common to houses erected in the first quarter of the 19th century. The porch has a wood deck and two Tuscan columns in the center, with plain posts at the corners, a replacement of the original outer Tuscan columns. The interior of the house was unavailable for observation, but Mr. and Mrs. Clarence M. Bohn, the current owners, state that the interior has been considerably altered and is divided into two apartments.

F-1- 700 Geotoe W. Myers Farm Head Frederick County Photo: Janet Davis July 1903 Nea- 100 2 Md. SHIPO, Crownsville, Md West elevation 1/6

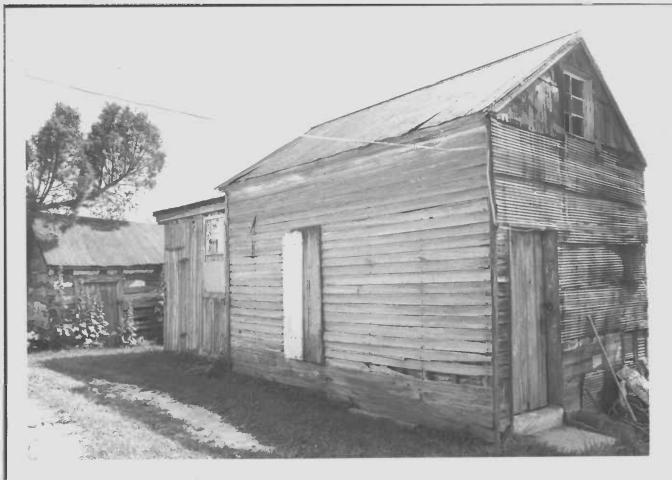
Summer kitchen: The frame summer kitchen is a 1-1/2 story frame building with weatherboard siding on the west elevation and an off-center vertical board door. The south elevation is partially covered with corrugated metal and has a second doorway. The roof is also covered with corrugated metal. No chimney is visible, but it was probably located at the north end. The interior was not accessible. The general condition of the buildings is fair. It appears to have been built about 1875.

Log smokehouse: The one-story exposed log smokehouse is at the north end of the group immediately behind the house. It has a corrugated metal roof and a vertical board door on the south elevation. It is also in deteriorated condition, but retains some plaster chinking on the exterior. The log building was probably built about 1850.

F 1-200 George W. Myers Farmstead Frederick County Photo: Jonet Davis July 1993 Neg. loc & Md. EHED. Crownsville, My Smokehouse and summer kitchen, view from south 2/6

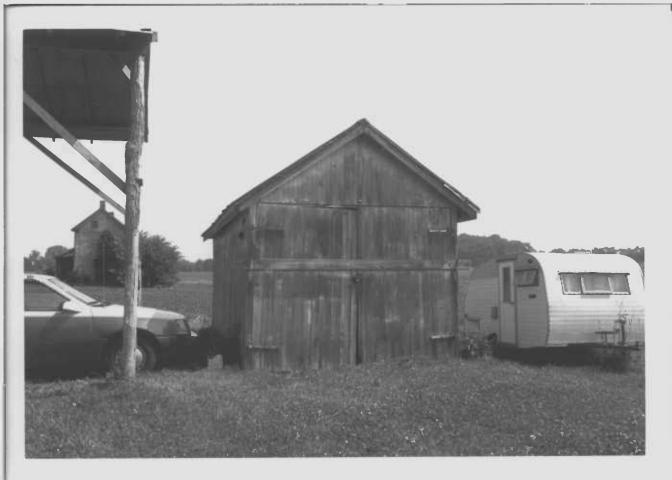
Garage: The small frame garage was built about 1900-1910 and is a gable roofed building with tongue-and-groove siding and a corrugated metal roof. Double swing doors are located on the south elevation.

F-1-200 GEOVAE W MYERS FORMSHED Frederick County Photo: Jonet Dows 1. 1993 Near loc.: Md SHIPO. Crownsville, Md. Garage south elevation

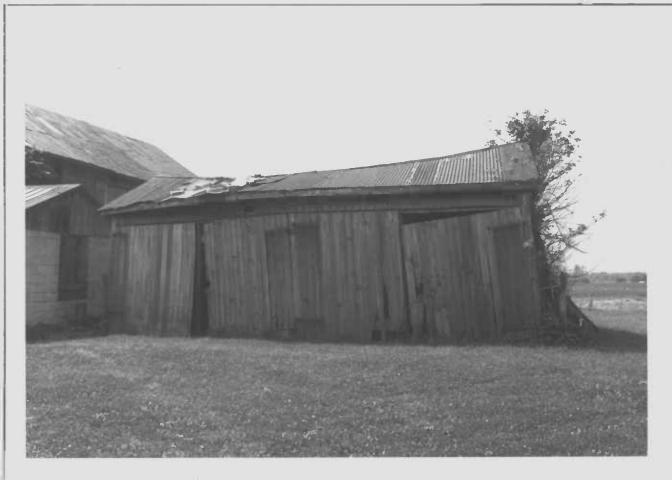
Agricultural outbuildings: The deteriorated bank barn, milk house, and equipment shed are located in a cluster southeast of the domestic group. The barn's forebay is on the east elevation, with the stall level partially enclosed by stone and wood bars. The upper structure has vertical siding, much of which is missing on the east and south elevations. Louvred vents on the east side have an unusual ogee arch profile. Semi-circular vents are in the north and south gable peaks. On the west elevation are double swing doors. The milk house is a small concrete block structure located near the northwest corner of the barn. Built about 1920-1930, it has 6/6 windows, a standing seam metal roof and vertical sided gables. Immediately west of the milk house is the equipment shed, a rectangular shed in very deteriorated condition, with a sagging corrugated metal roof. The north side of the shed has vertical board swing doors in two sets. The siding on the rest of the shed is vertical boards. The barn was probably built about 1850 and the shed may date from about 1900-1910.

F-1-200 George 11. Myers Farmstead Frederick Courty Photo: Janet Davis Neg. local Mid SHPO Cheensulle Mid Shed north eleustion

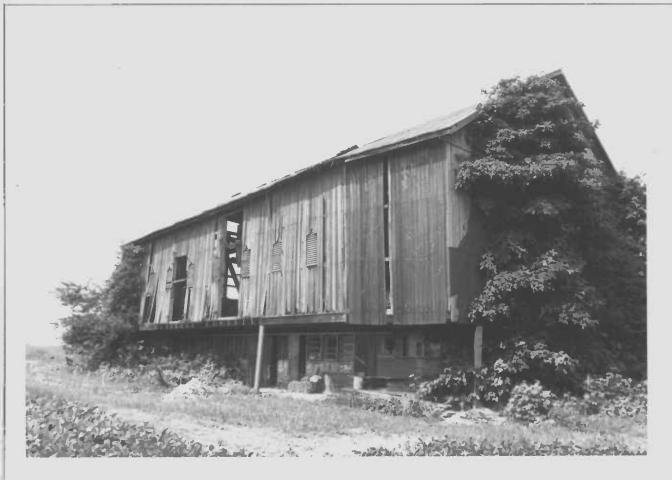
F-1-200 George W. Myers Formstead Frederick County Photo: Jonet Dows July 1903 Near loc. : Md. SHPO Crownsville Md Farn, northeast corner view 5/6

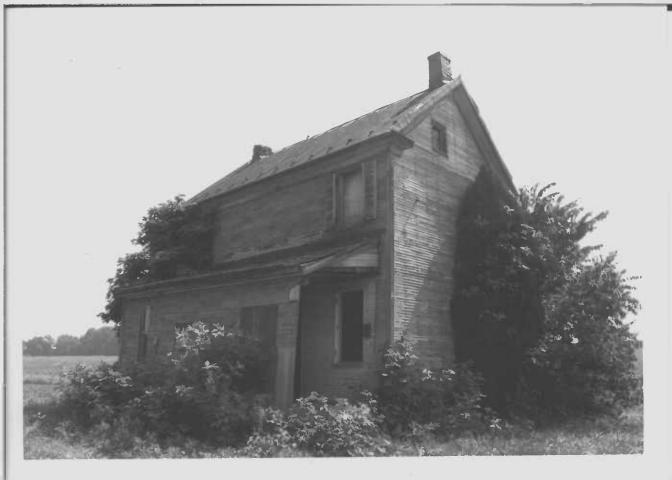
Tenant House: The tenant house is located about 200 feet north of the main dwelling and domestic outbuildings. Currently unoccupied and deteriorated, it is a two-story frame structure with three bays on the first story of the west elevation and two on the second. The one-story porch on the west is partially enclosed. The original siding is narrow weatherboards with the west and north elevations covered with artificial brick-patterned siding. The roof is standing seam metal with interior end chimneys. The window and door openings are empty, although some louvred shutters are still in place.

F-1-200 George W. Myers Formstead Frederick County Photo: Jonet Dows July 1993 Neg. Go. : Md. SHPO, Crownsulle, Md. Tenant house, southwest corner view 6/6
